Pitting Corrosion of Cast Aluminium Cistern due to Deposition of Copper Ions

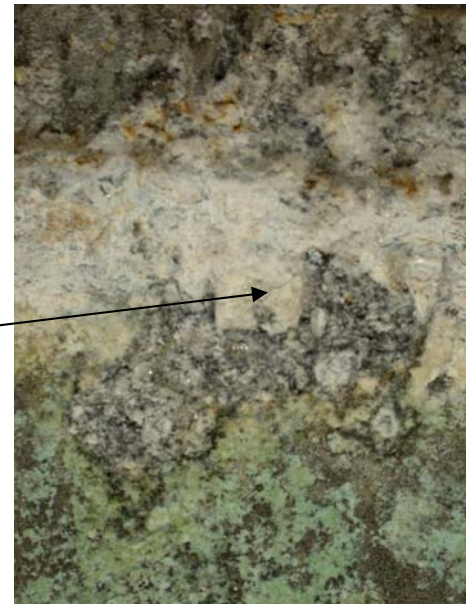
Pitting at the water line

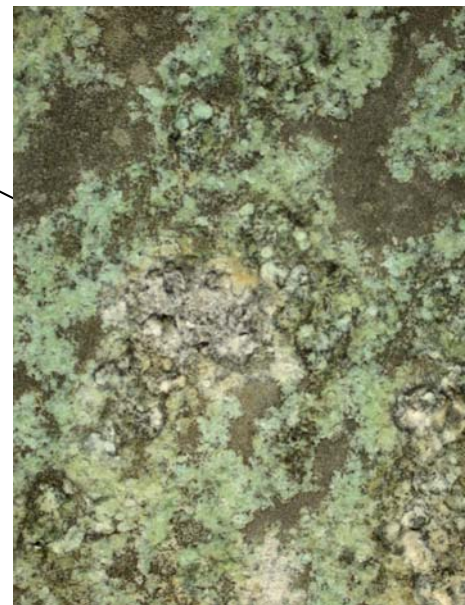
Pitting in area of copper deposition
Below the water line
